**Flight Service Evaluation of
Kevlar-49 Epoxy Composite Panels
in Wide-bodied Commercial
Transport Aircraft**

Eighth Annual Flight Service Report

R.H. Stone

LOCKHEED-CALIFORNIA COMPANY
BURBANK, CALIFORNIA

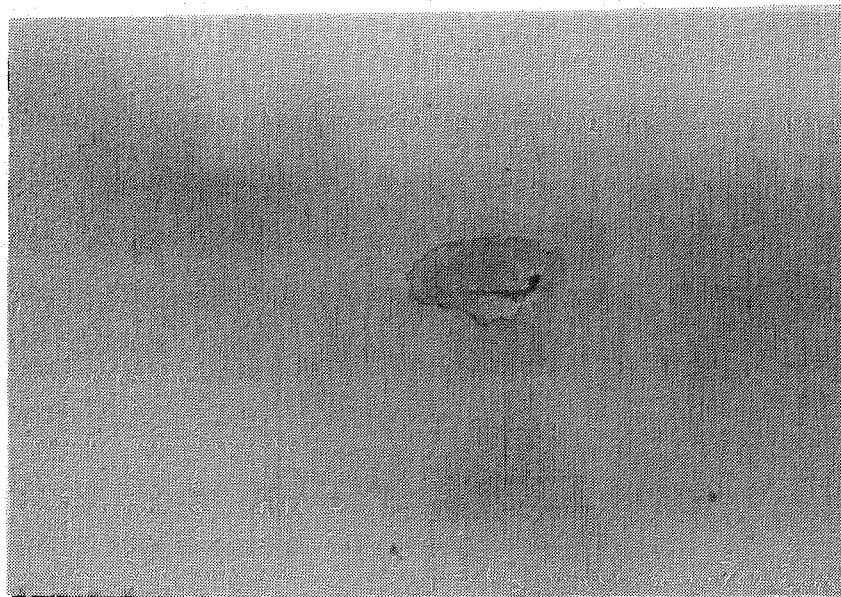
1. Two exterior surface cracks observed in earlier inspections had not propagated or changed in appearance. These were a 0.3 cm (1/8 in.) crack in the center area first observed in 1976, and a 0.6 cm (1/4 in.) crack in the forward center area first observed in 1975. (Figure A-1)

Figure A-1. - Air Canada Right-Hand Wing-Body Fairing -
0.6 cm Crack on Exterior.

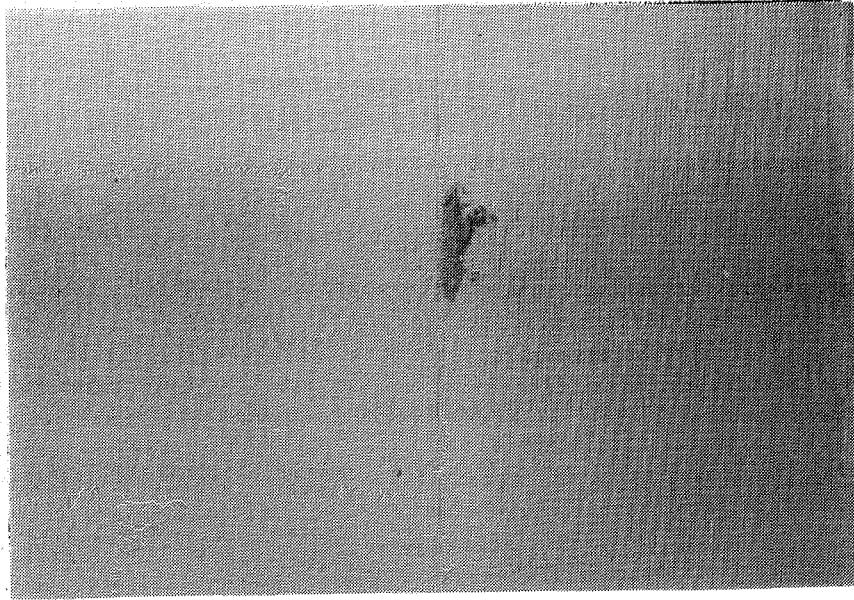
4. A gouged area with loose fibers, 1.9 cm (3/4 in.) in length in the lower forward area of the inner surface (Figure A-2), had not changed or increased in size since first observed in 1979.

Figure A-2. - Air Canada Right-Hand Wing-Body Fairing -
Gouged Area on Inner Surface.

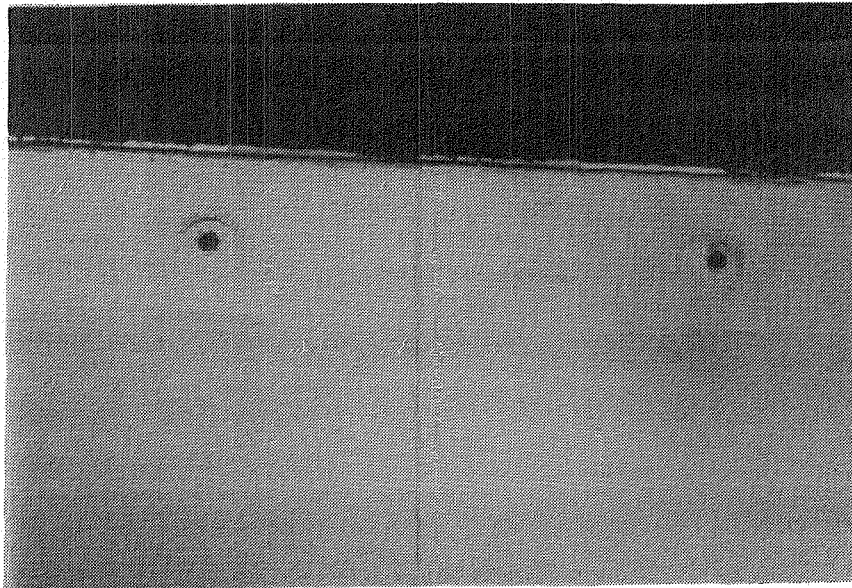
7. Slight fraying was observed on all fastener holes on the top, forward and aft edges. There was a greater degree of fraying along with a distinct fastener markoff on the lower edge. (Figure A-3). This condition has remained unchanged from the previous inspections.

Figure A-3. - Air Canada Right-Hand Wing-Body Fairing -
Frayed Holes on Lower Edge.

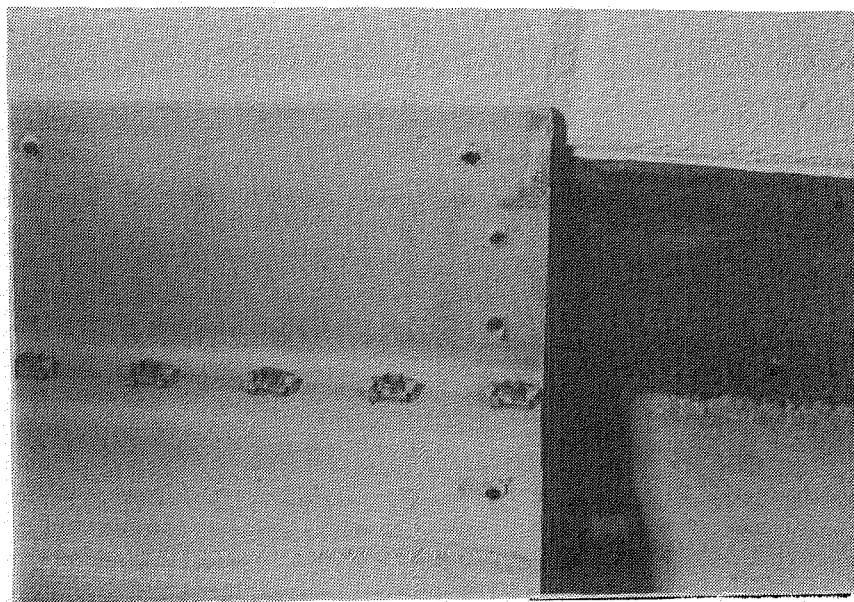
1. No exterior defects or damage was noted. Extensive paint loss was observed with about 60 percent of the Kevlar-49 exposed in the upper section. This indicates possible exposure to Skydrol.
2. All of the fastener holes showed some fraying and fuzz (Figure A-4). Six holes (out of 19) showed a significantly greater degree of fraying than the others. About half the holes showed measurable elongation to a 0.55 cm (7/32 in.) diameter from the original 0.5 cm (3/16 in.) diameter (Figure A-4). One hole was elongated to 0.6 cm (1/4 in.). There was no correlation between the frayed and elongated holes.

Figure A-4. - Air Canada Right-Hand Underwing Fillet - Frayed and Elongated Holes.

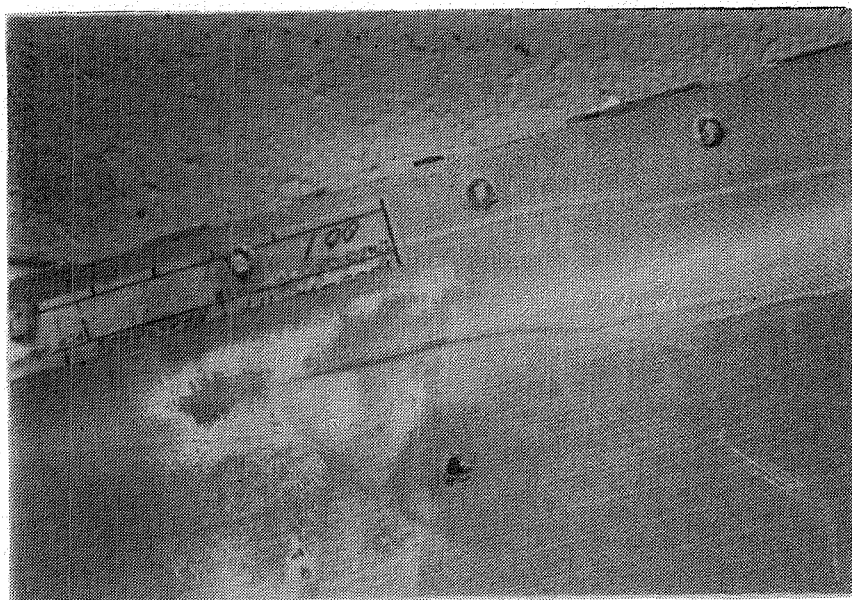
1. No exterior surface defects, damage, or paint loss was observed.
2. All of the fastener holes were heavily frayed (Figure A-5). A small number of holes were slightly elongated; three holes were elongated to 0.55 cm (7/32 in.) and one hole to 0.6 cm (1/4 in.) from the original 0.5 cm (3/16 in.) dimension.

Figure A-5. - Air Canada Left-Hand Aft Engine Fairing - Frayed Edge and Intercostal Holes.

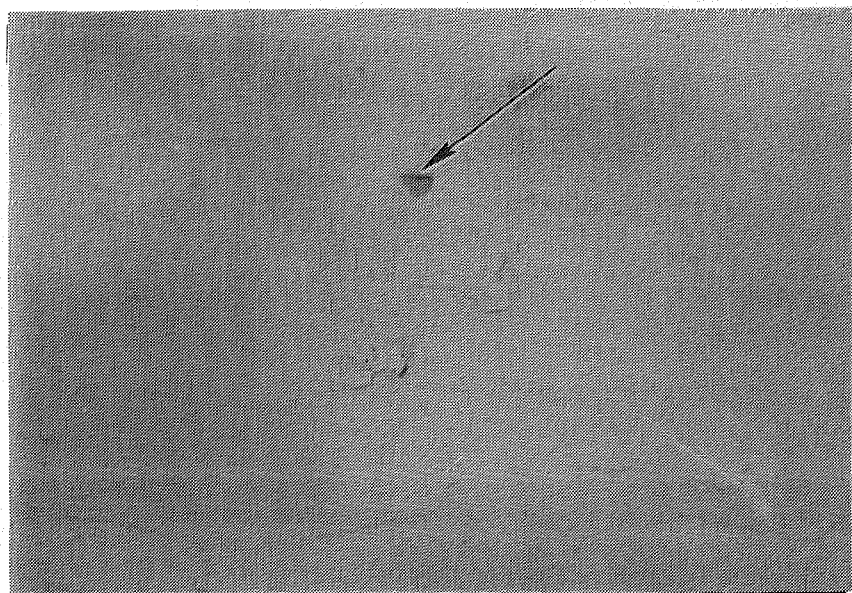
Figure A-6. - Air Canada Left-Hand Wing-Body Fairing - Deep Gouge on Panel Exterior.

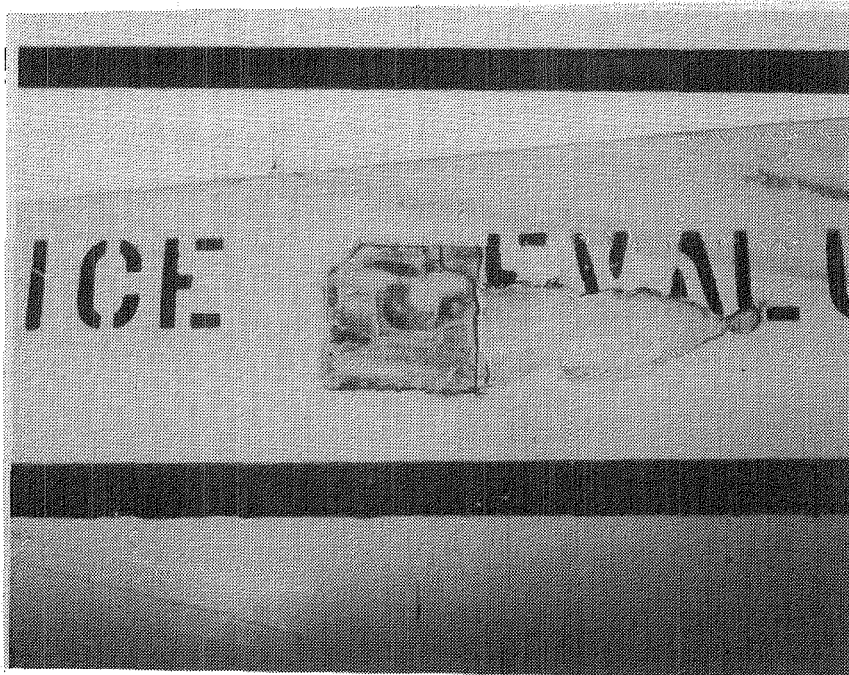
Figure B-1. - TWA Left-Hand Wing-Body Fairing -
Tape Patch Repair of Couge.

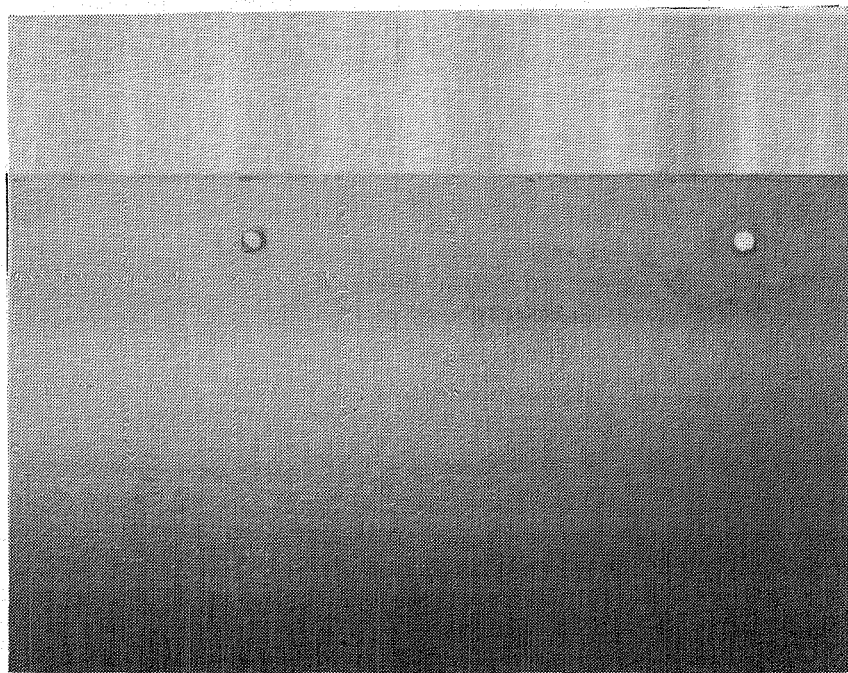
4. An area of extensive paint loss along the forward edge was still present, but had not increased in area. This may be indicative of Skydrol.
5. Slight fraying was observed on most fastener holes, but in general this part has less fraying than the other wing-body fairing panels (Figure B-2). The aft and lower edges were slightly more frayed than the forward and upper edges.

Figure B-2. - TWA Left-Hand Wing-Body Fairing - Typical
Fastener Holes with Slight Fraying.

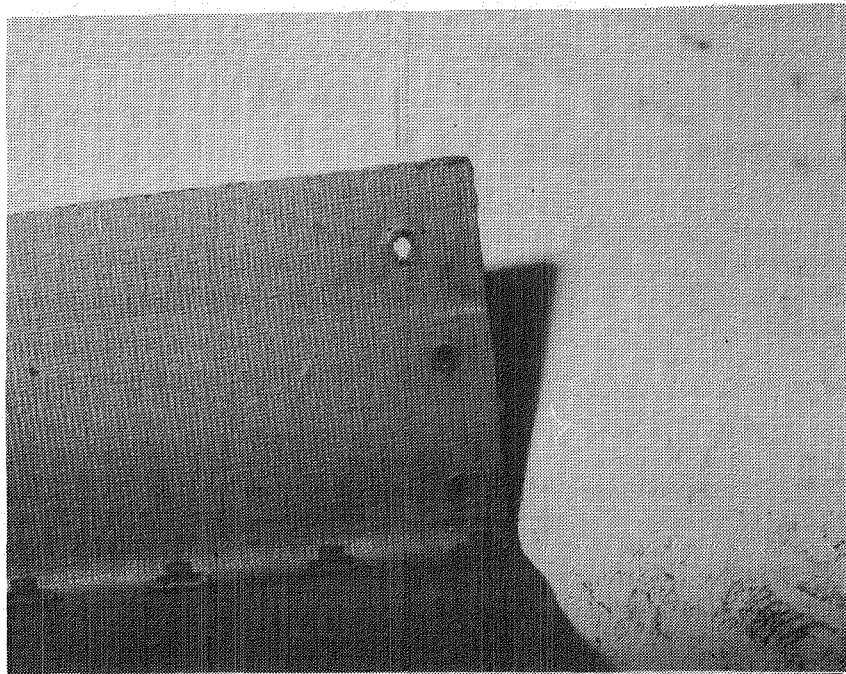
Figure B-3. - TWA Right-Hand Underwing Fillet -
Frayed and Elongated Fastener Holes.

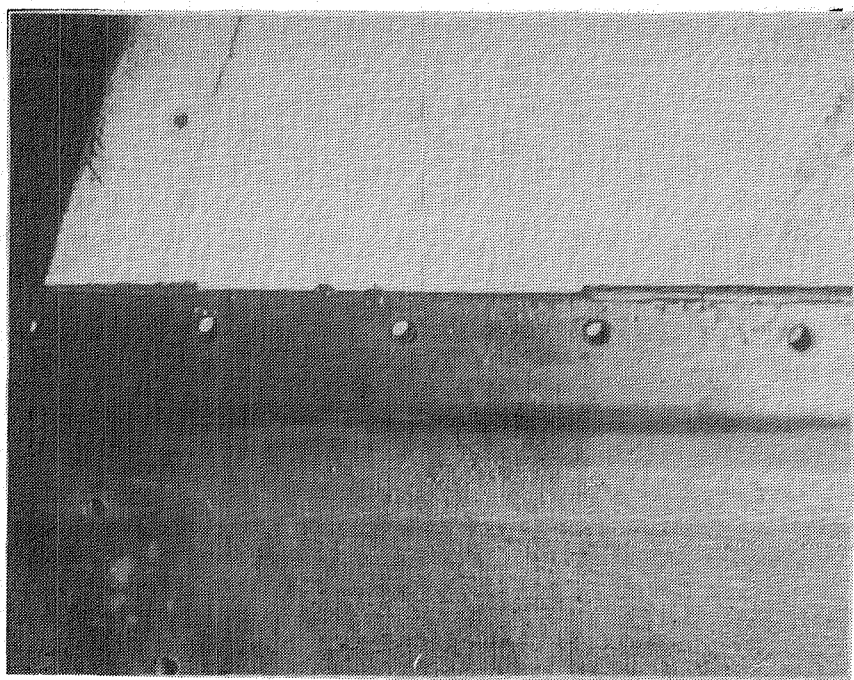
2. Several holes on the upper edge were slightly frayed, but in general the frayed condition was absent (Figure B-4). All holes on this part had been relocated at the time of reinstallation, and a surface layer of resin impregnated 120 fiberglass fabric had been bonded to both surfaces prior to drilling the relocated holes. This effectively eliminated the fuzziness or frayed condition noted on the other parts.

Figure B-4. - TWA Right-Hand Aft Engine Fairing - Fastener
Holes Showing Absence of Frayed Condition.

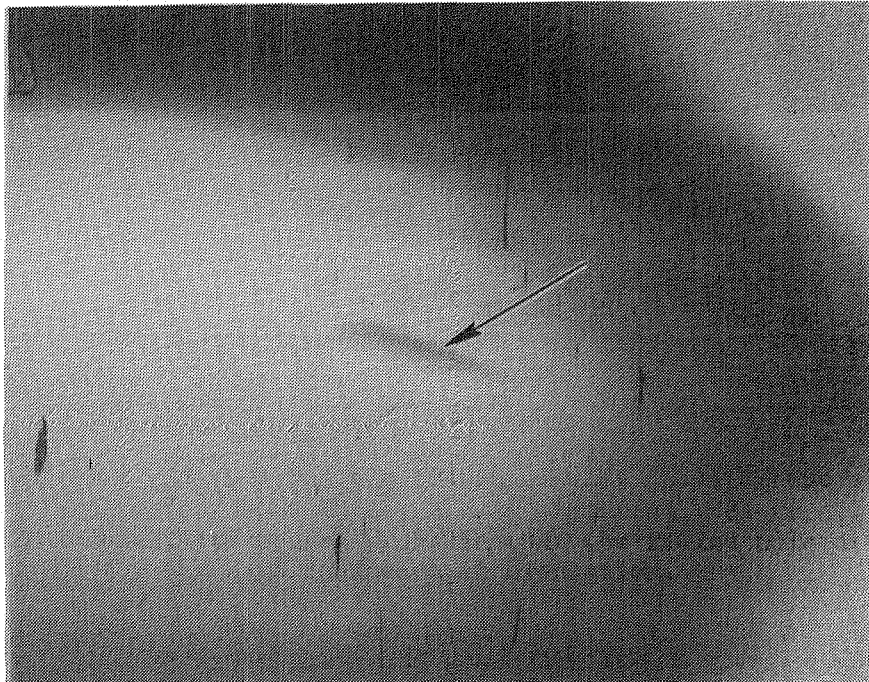
Figure B-5. - TWA Right-Hand Wing-Body Fairing -
Disbonded and Crushed Area.

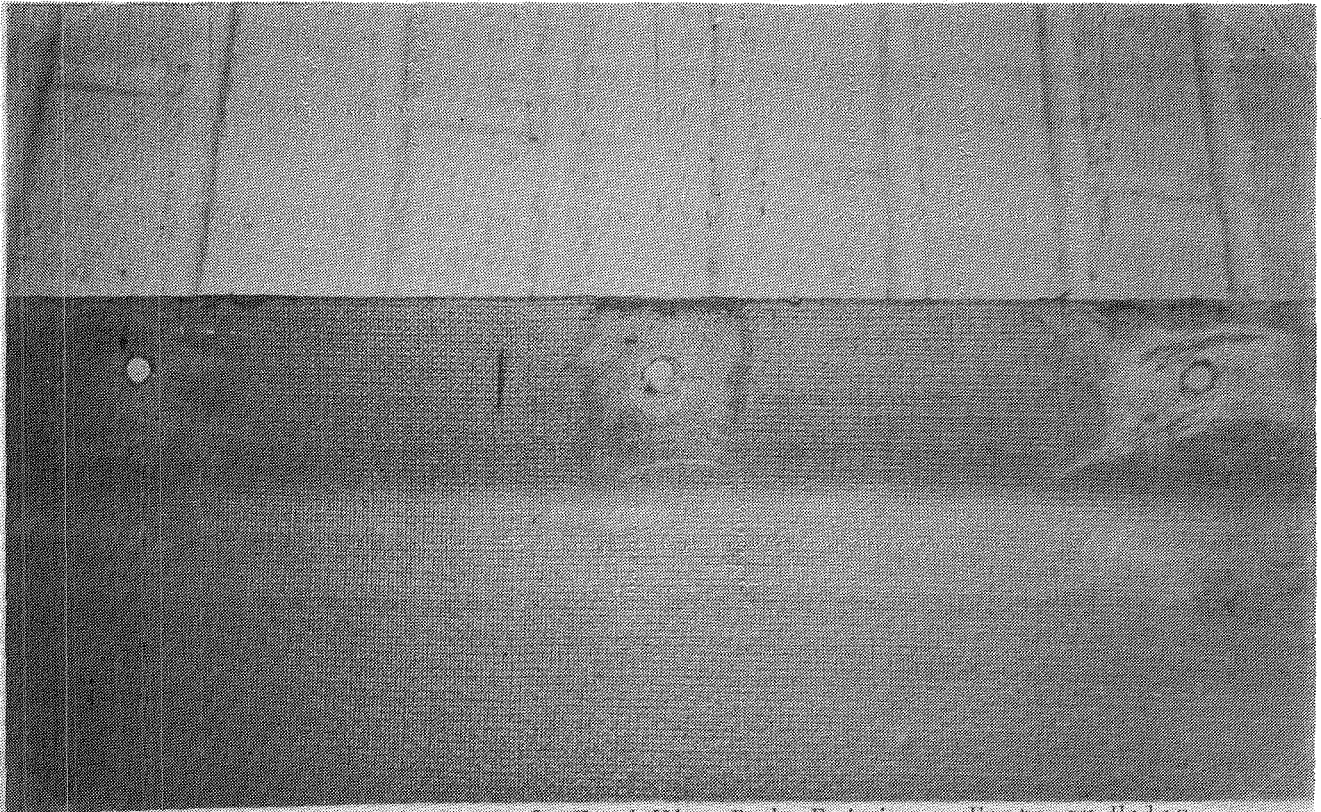
Figure C-1. - Eastern Left-Hand Wing-Body Fairing - Fastener Holes With Slight Fraying.

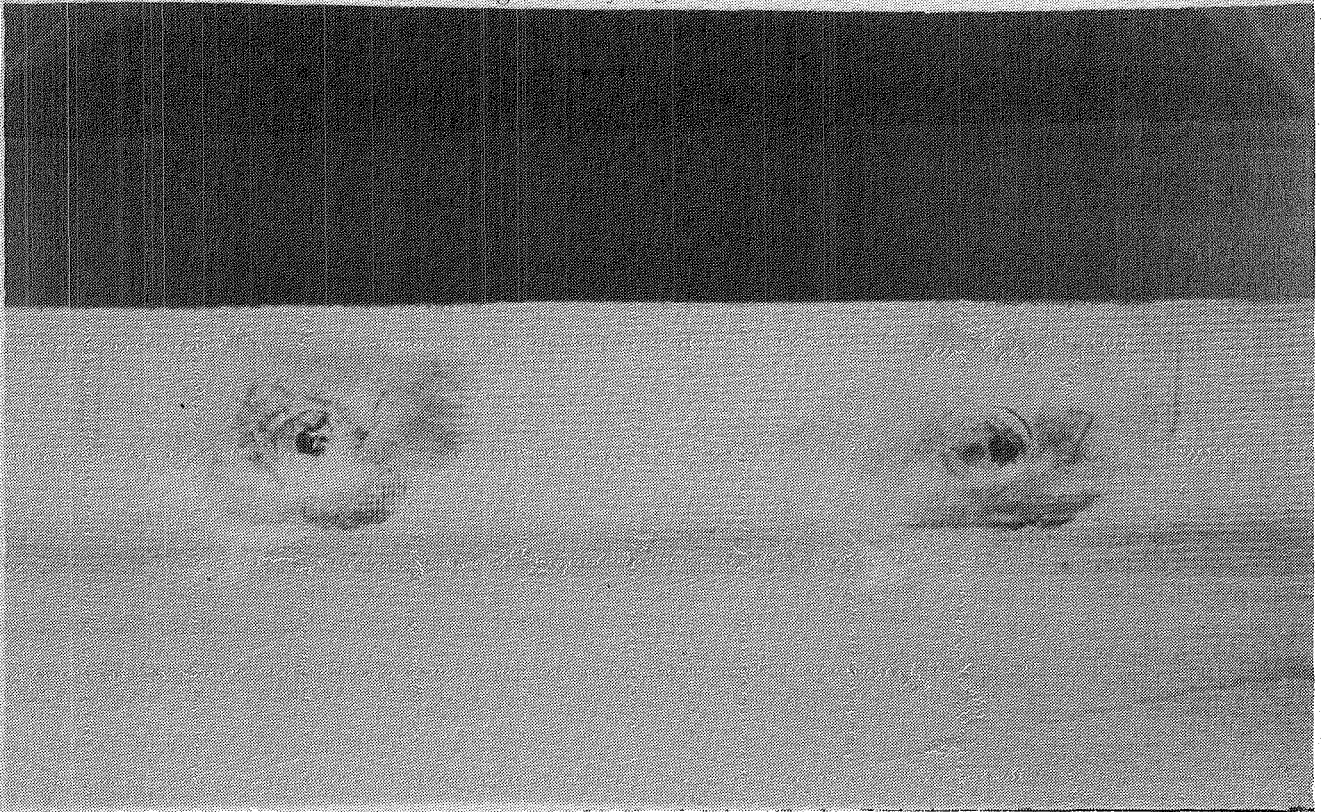
Figure C-2. - Eastern Left-Hand Wing-Body Fairing - Fastener Hole With Frayed Appearance.

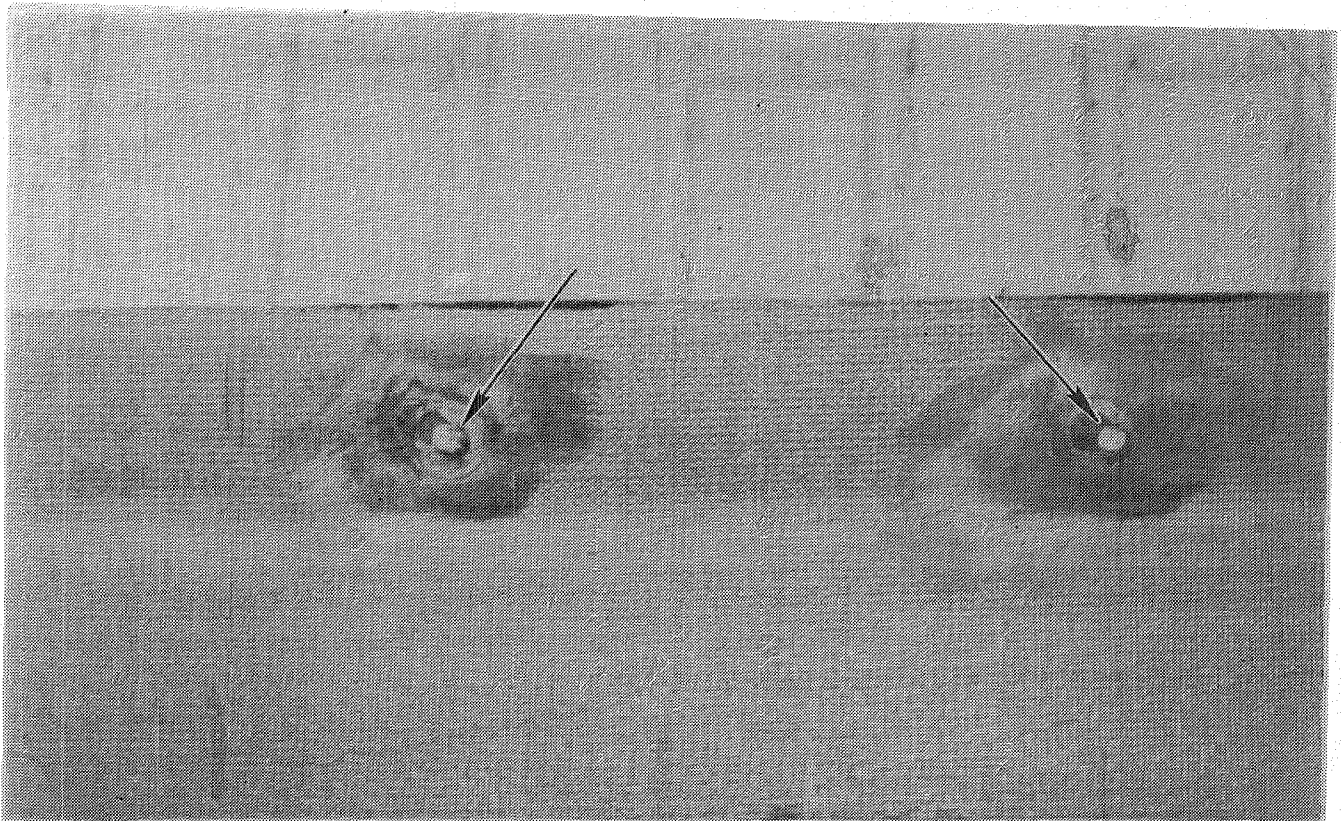
Figure C-3. - Eastern Left-Hand Wing-Body Fairing - Fastener Holes With Fraying in Kevlar-49 Area and Elongation in Filler.

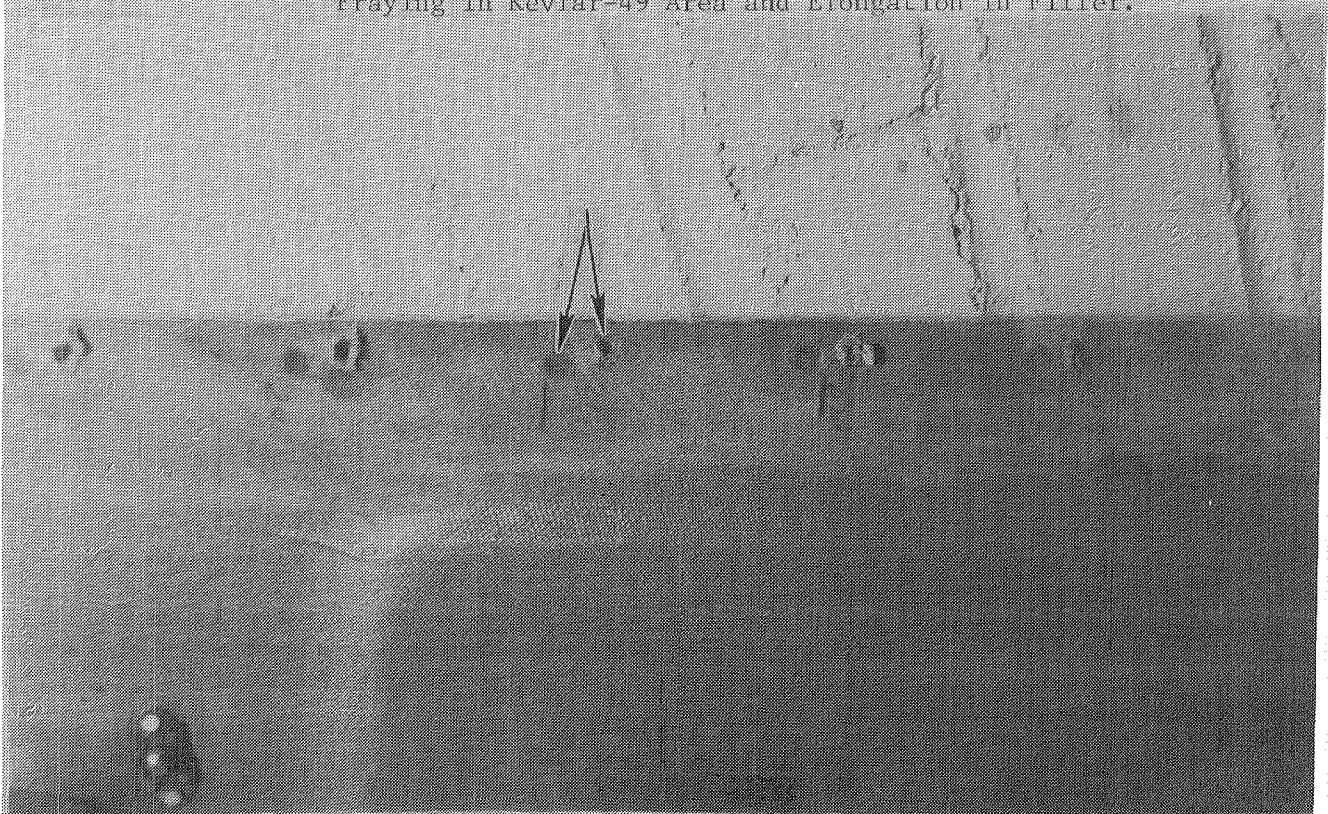
2. Most of the fastener holes in this part were redrilled through the Kevlar-49 and were fully offset from the filled area (Figure C-4). These holes were all extremely frayed (Figures C-5 and C-6), and the fuzziness and frayed condition was noticeably worse than the holes previously observed on this program. Elongation was noted in about 20 holes (out of a total of approximately 110 holes), and this elongation occurred mainly in areas where the hole was redrilled through a portion of the filled original hole. The elongations ranged from 0.55 cm (7/32 in.) to 0.6 cm (1/4 in.) compared to the original 0.5 cm (3/16 in.) diameter.

Figure C-4. - Eastern Left-Hand Aft Engine Fairing - Frayed Fastener Holes Showing Offset From Filled Areas.

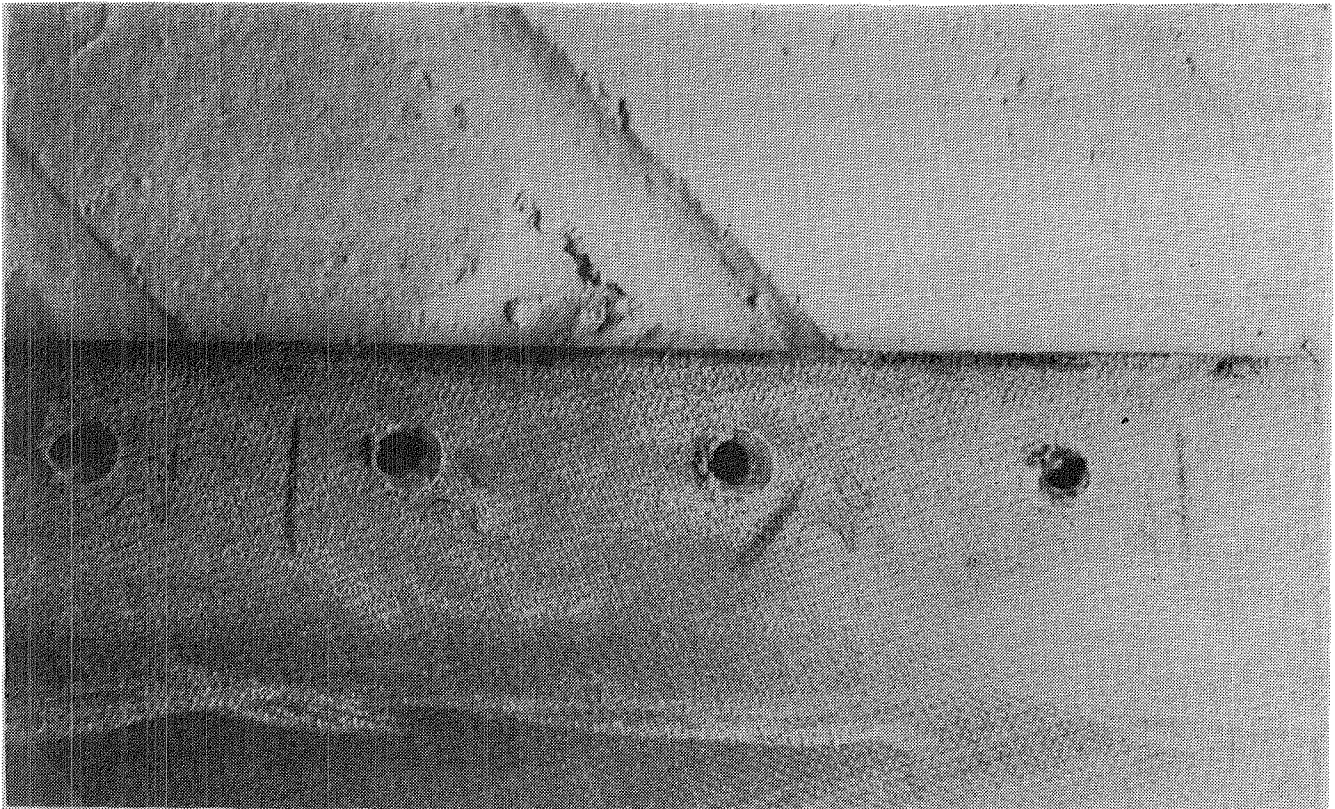
Figure C-5. - Eastern Left-Hand Aft Engine Fairing - Frayed Fastener Holes Along Edge.

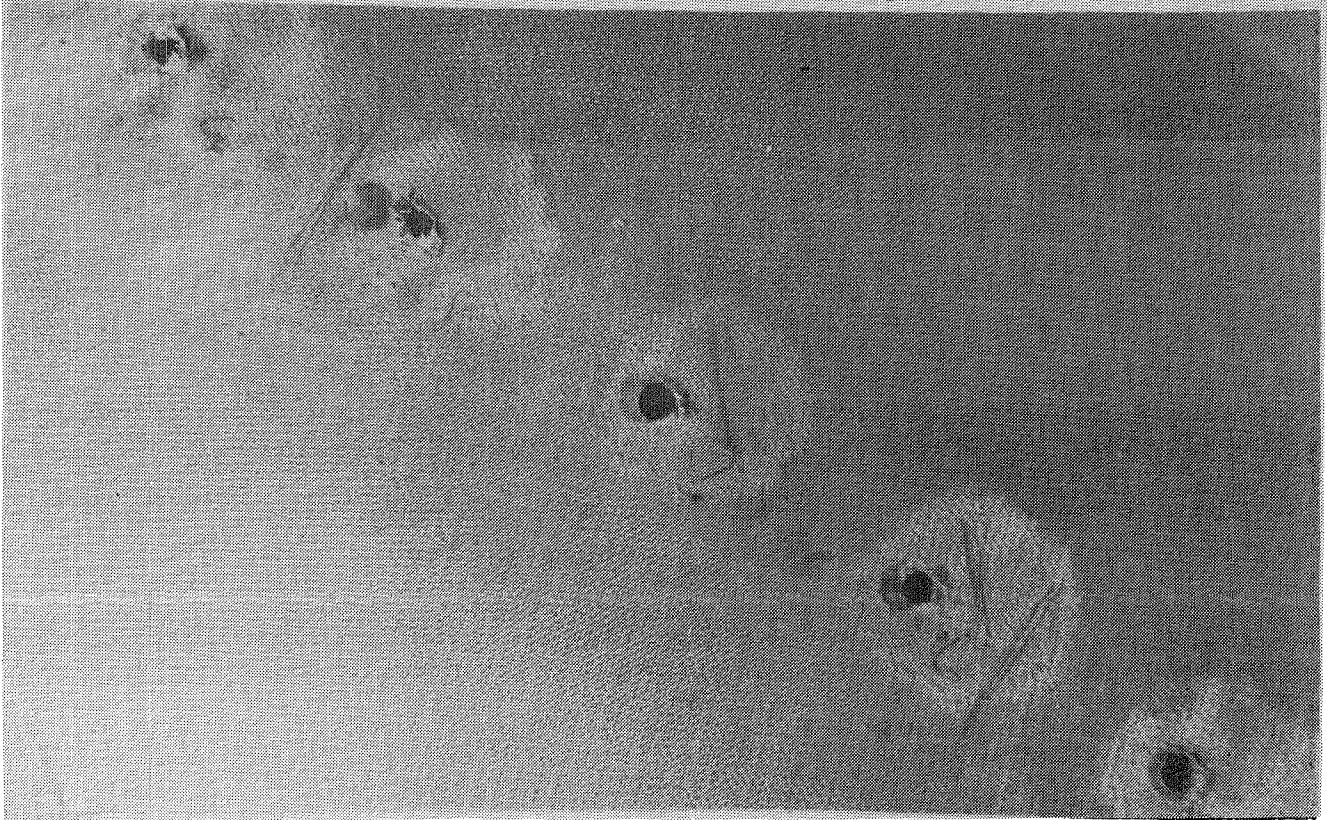
Figure C-6. - Eastern Left-Hand Aft Engine Fairing - Frayed Fastener Holes Along Intercostal.
